**TITLE** : Changed outlet stop (flapper) grinder

**MODEL** : Sprso all models

**NUMBER** : SI250311

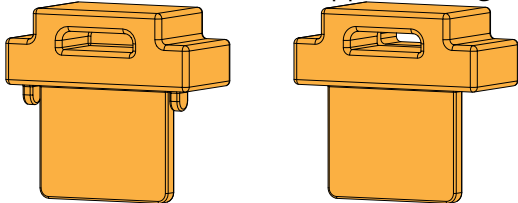
We have changed the outlet stop grinder because in some situation the outlet stop was creating too much friction inside the grinder which resulted in more wear than normal. In some cases the grinder would not grind any coffee anymore.

The modification of the flapper is recognizable as shown in the pictures below.

Old

New
